APS Home Inspection Service

1234 School House Road
Yourtown, US 12345

General Information

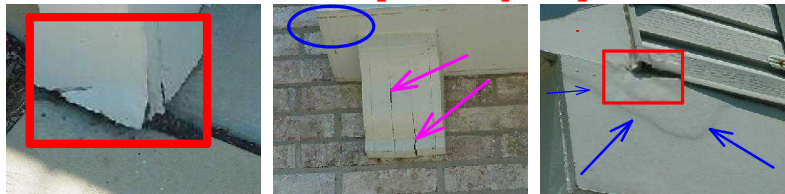
1. Water damage to trim wood at either side of garage door from moisture wicking into the finished particle board. The surface is starting to delaminate. Recommend repair/replacement of the trim boards and silicone seal wood that is in contact with concrete to prevent wicking.

2. The wood window boxes have water damage and will require repair/replacement. The wood has started to separate at the supports and at the corners of the window boxes.

3. The trim board at the southwest corner of the porch has water damage due to water penetration and will require repair/replacement of the wood. The trim board extends out creating a ledge allowing water to collect on the top edge of the board and cause the wood to rot.

Recommend estimate/repairs by a qualified contractor.

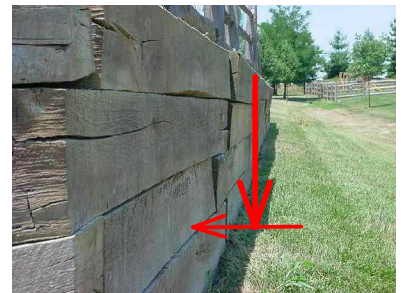
1. Vegetation: Shrubs with some weeds
2. Retaining Walls: Railroad ties The wall is showing signs of movement, but appears to be stable at this time. A qualified contractor is recommended to evaluate and estimate repairs to maintain the wall.
