APS Inspection Service
1582 Victoria Ave
Lakewood, OH 44107

Commercial Inspection Report

8611 Detroit Ave
Cleveland, Ohio 44102

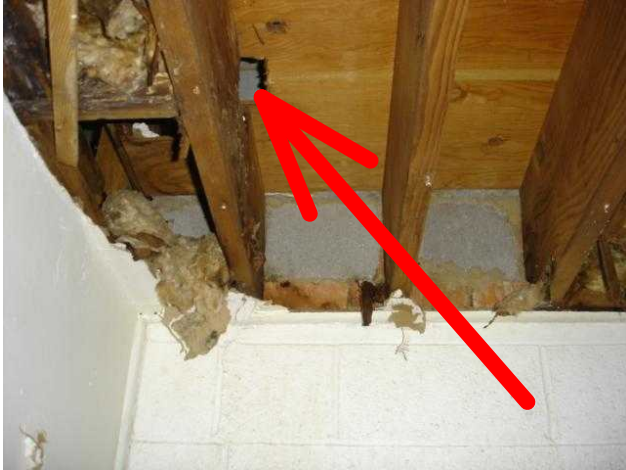
Cut Floor Joist

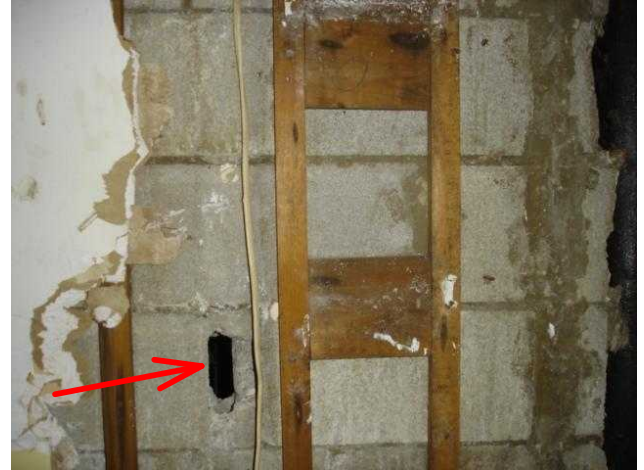
Whole knocked in the block

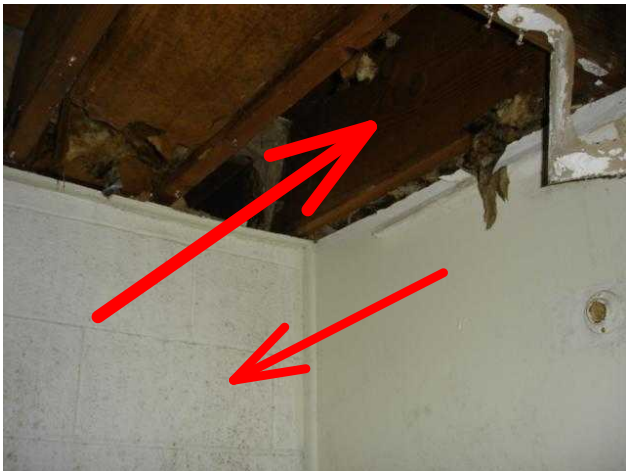
Mold

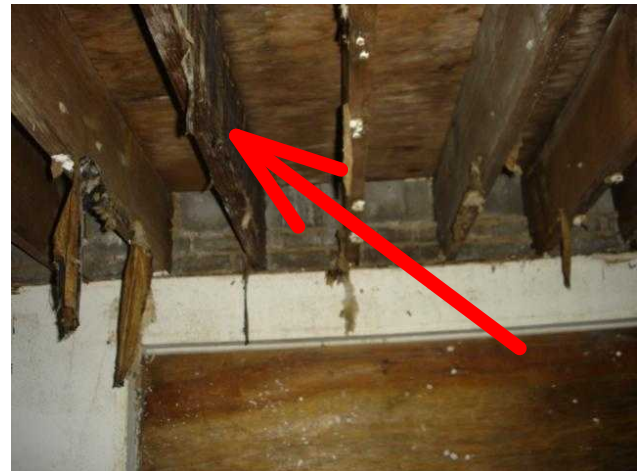
Wood rot in the floor joist

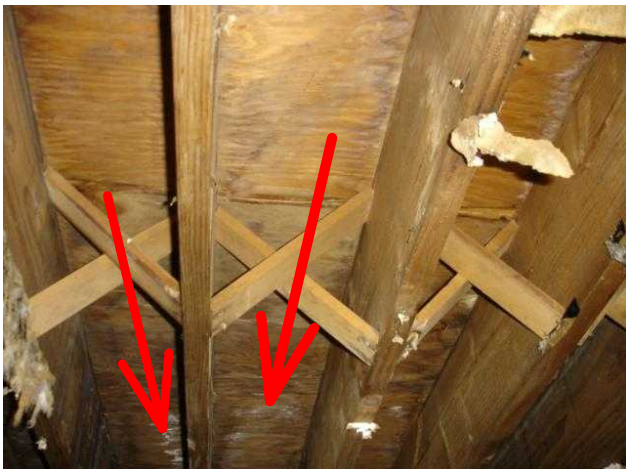
Mold and wood rot

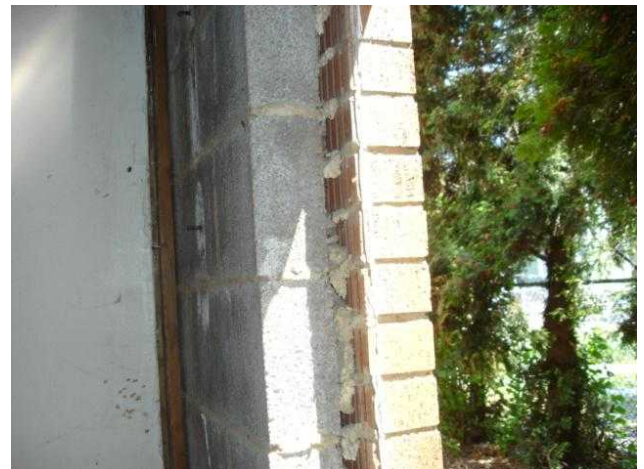
Block and brick veneer

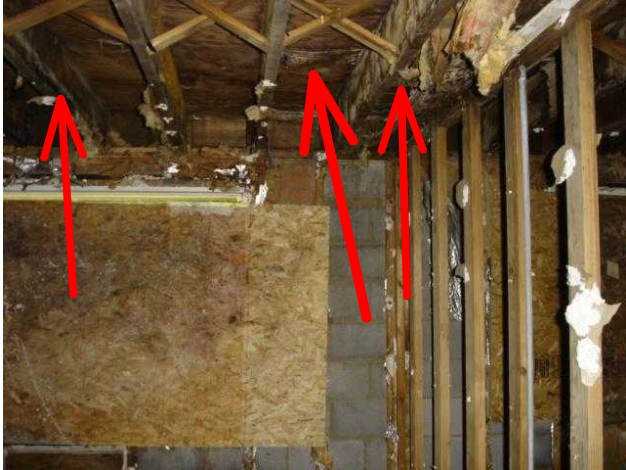
Wood rot

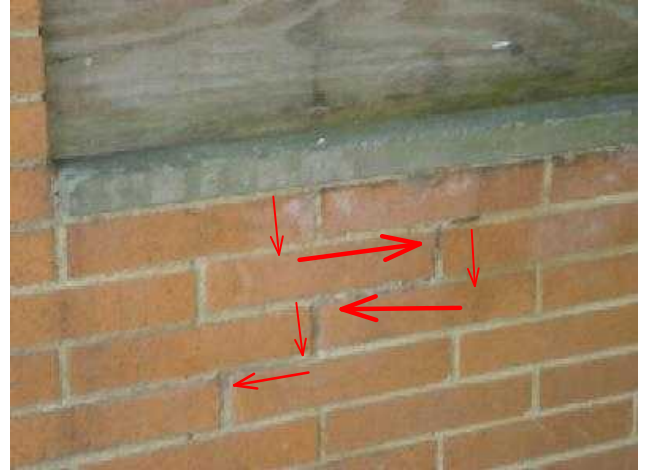
Foundation Cracks

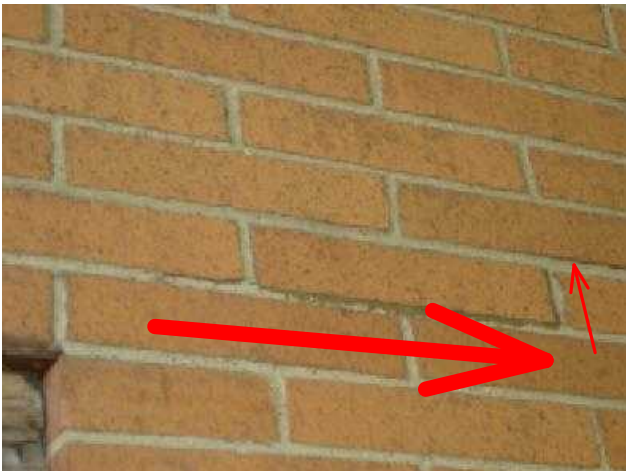
Foundation Cracks

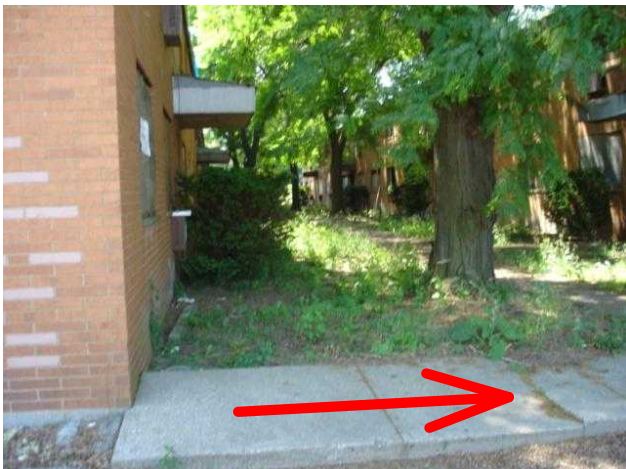
Broken side walks

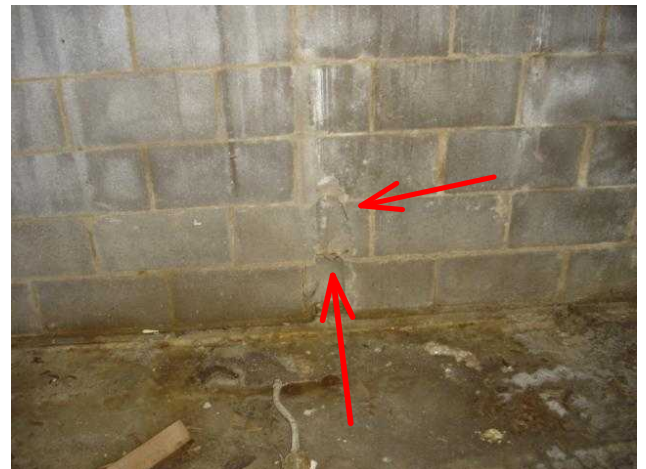
Foundation Holes

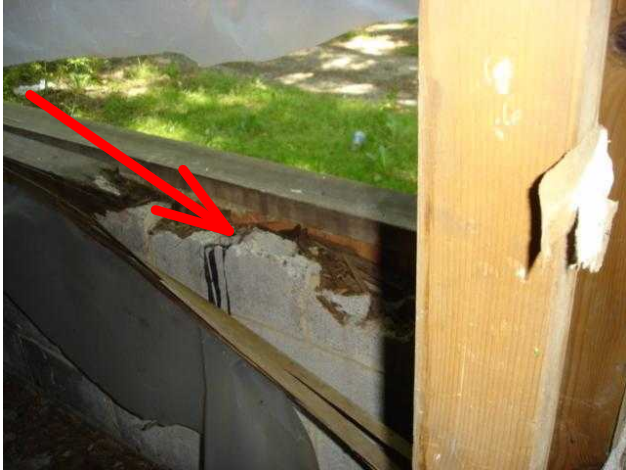
Broken Block

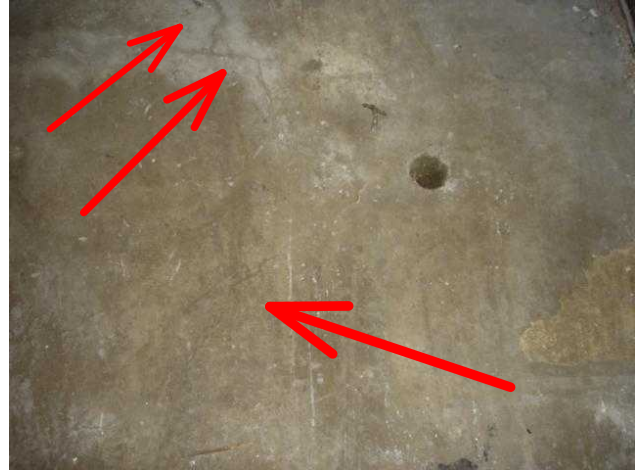
Foundation Slab cracks

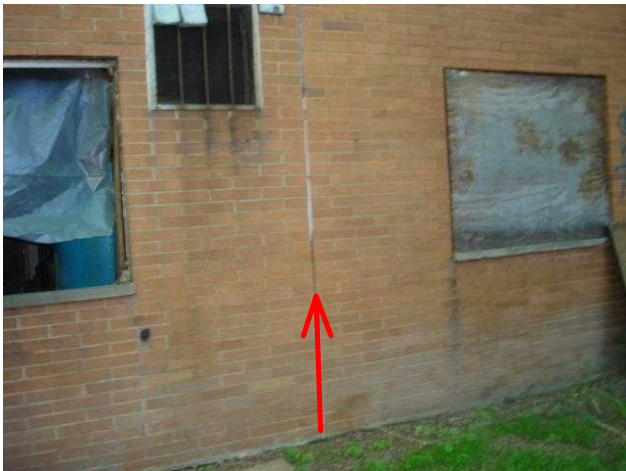
Joints show settlement

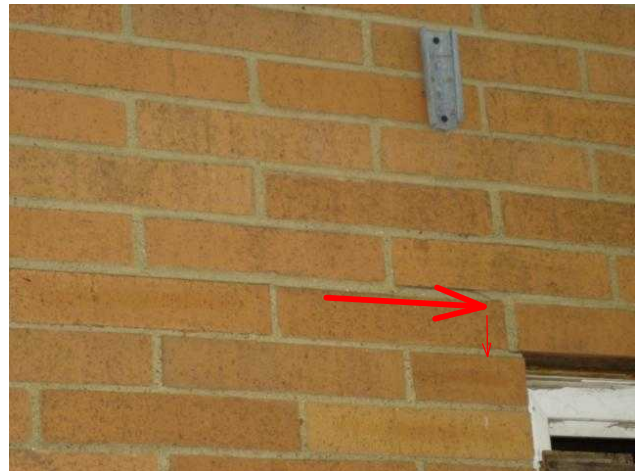
Stress cracks

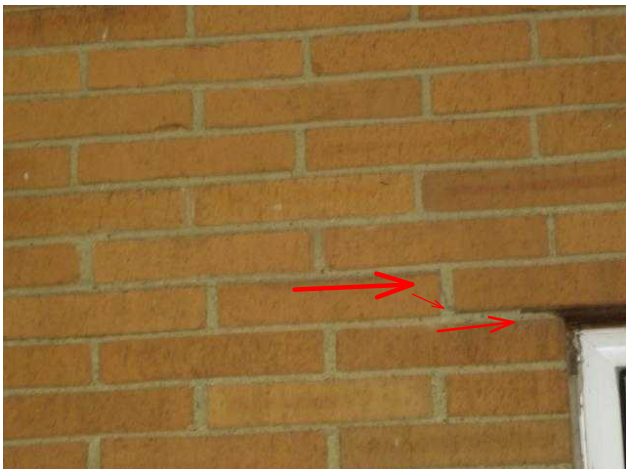
Stress cracks

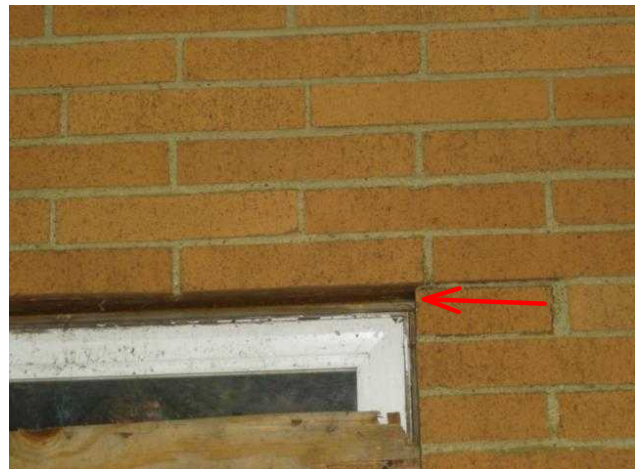
Stress cracks

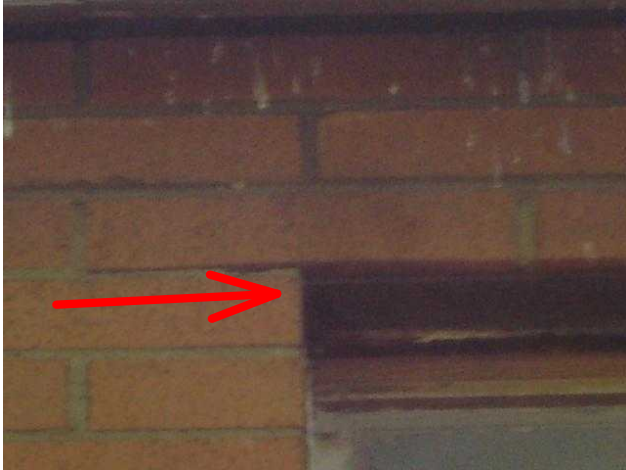
Stress Cracks

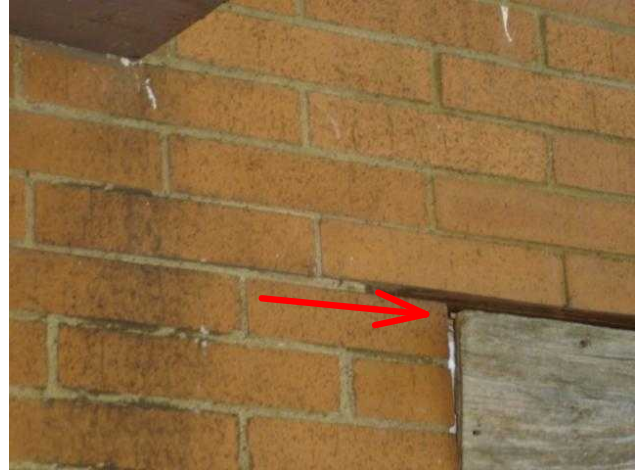
Stress Cracks

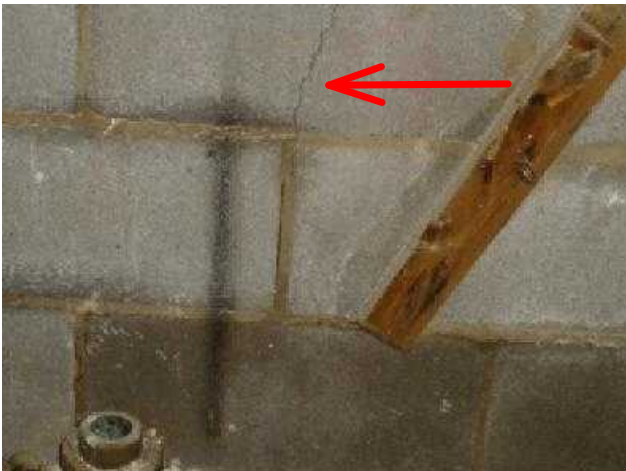
Stress Cracks

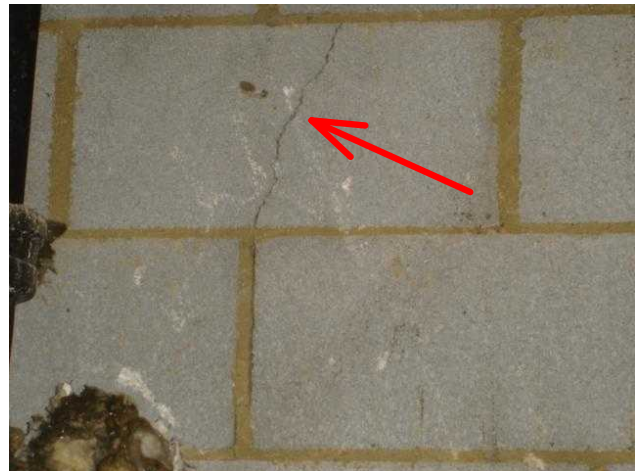
Stress Cracks

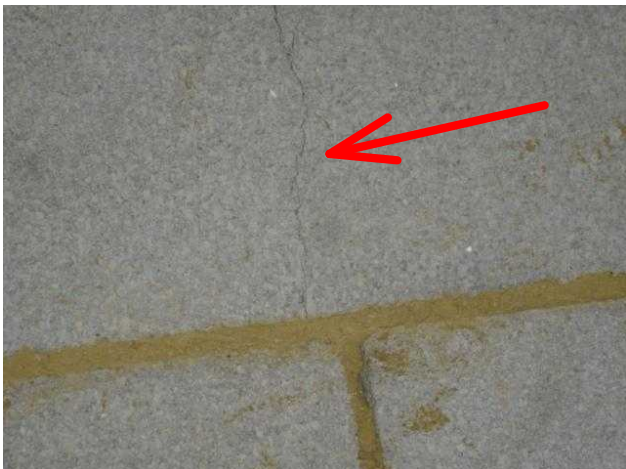
Stress Cracks

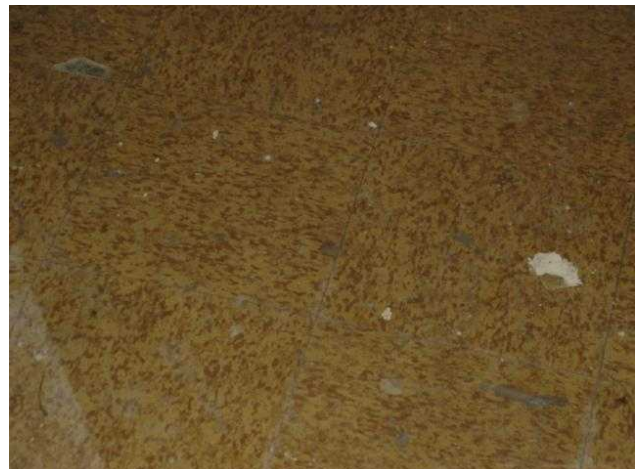
Asbestos Tile

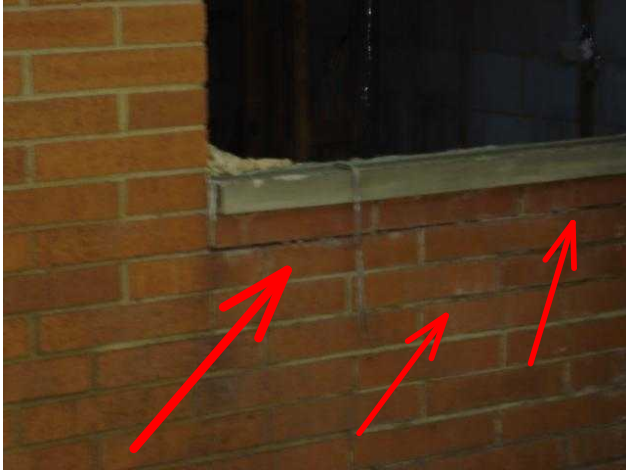
Stress Cracks

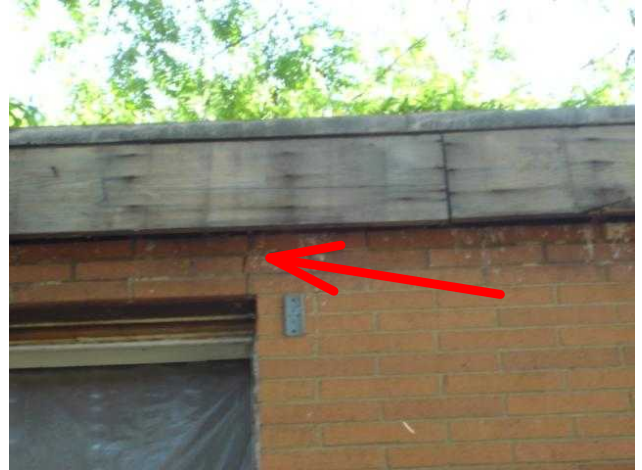
Stress Cracks

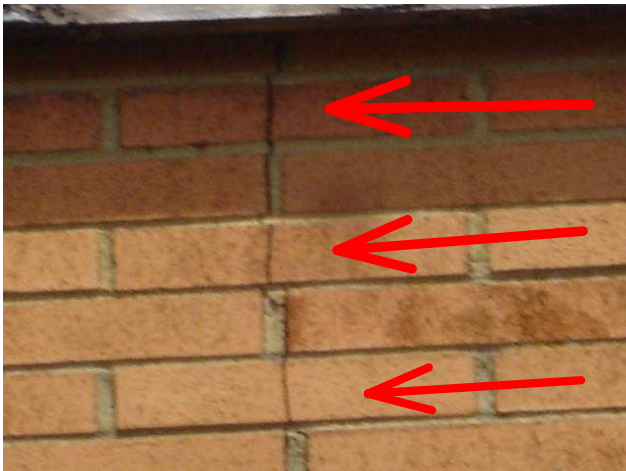
Stress Cracks

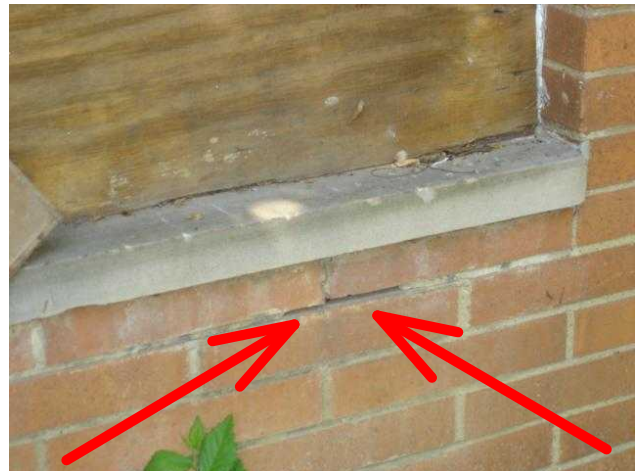
Stress Cracks

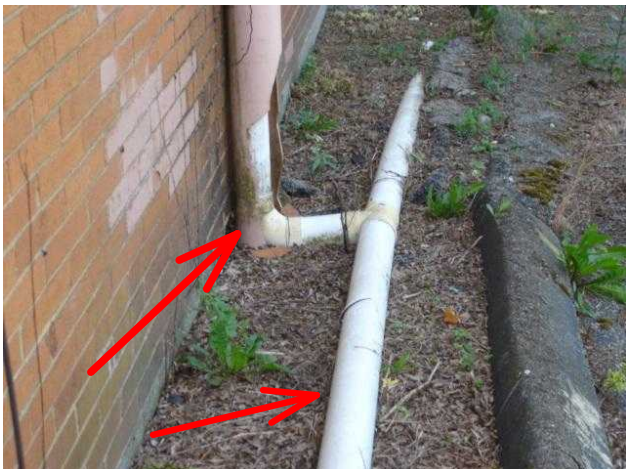
The drainage may be the problem with the slab cracks

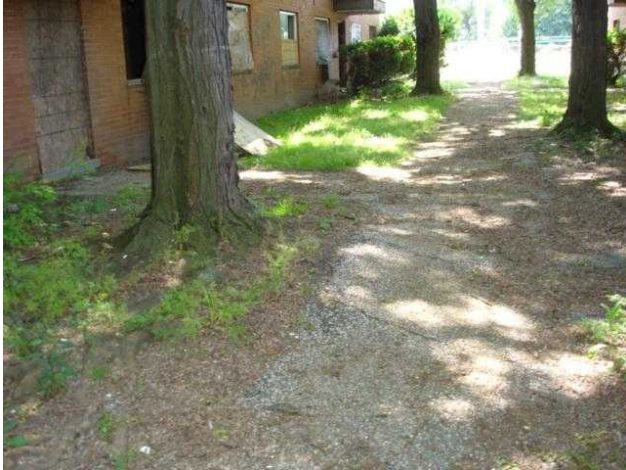
Trees are up-rooting pavement.

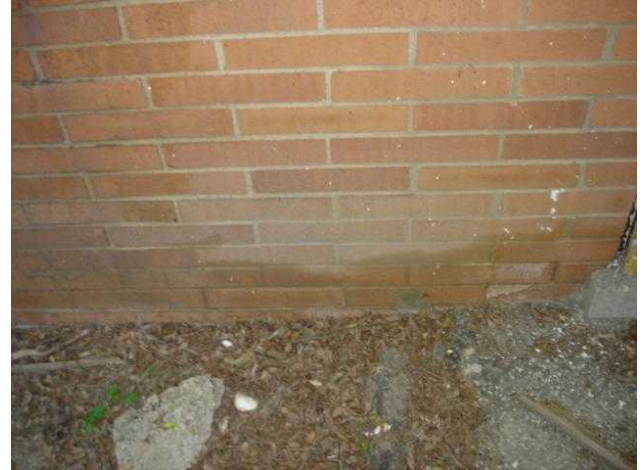
Moisture in the walls

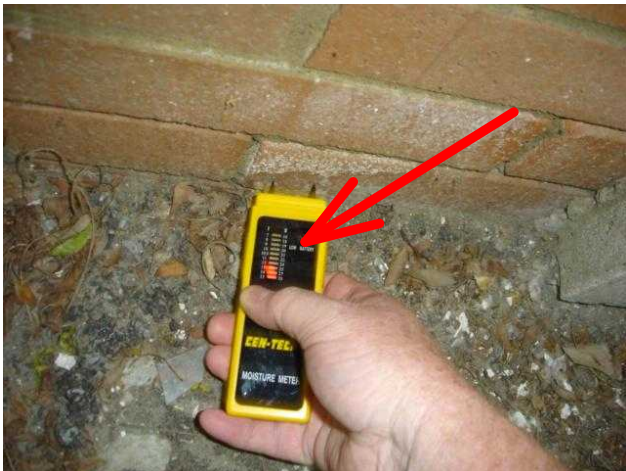
Light shows moisture in the walls on the high side of the meter.

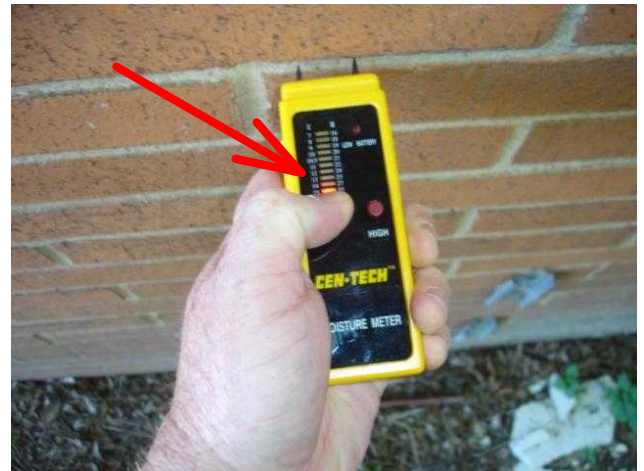
Moisture in the walls

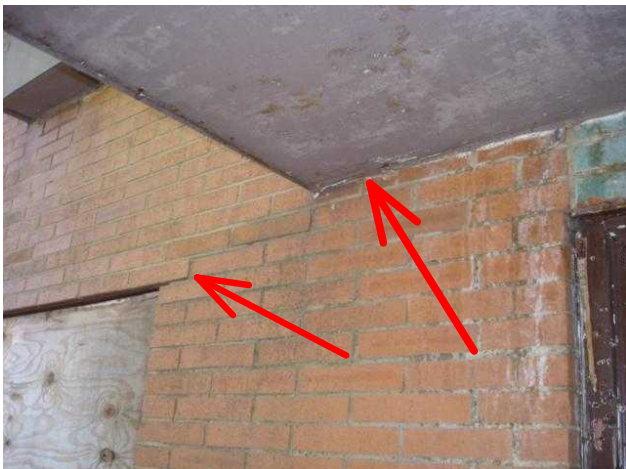
Stress Cracks

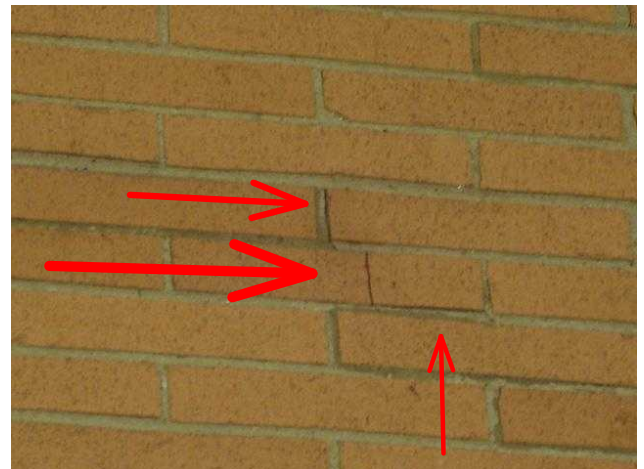
Stress Cracks

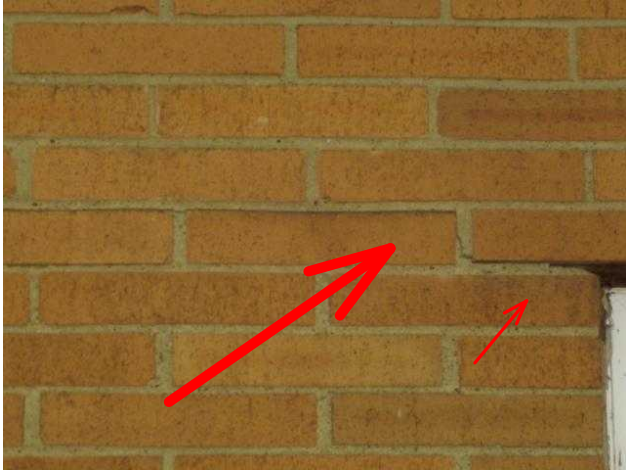
Stress Cracks With Displacement

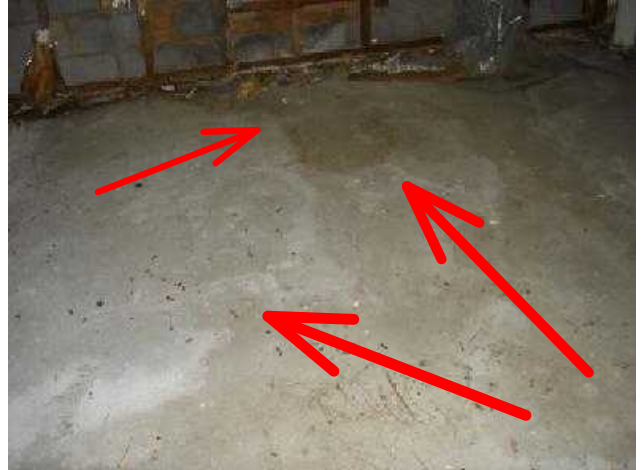
Stress Cracks in the slab with moisture

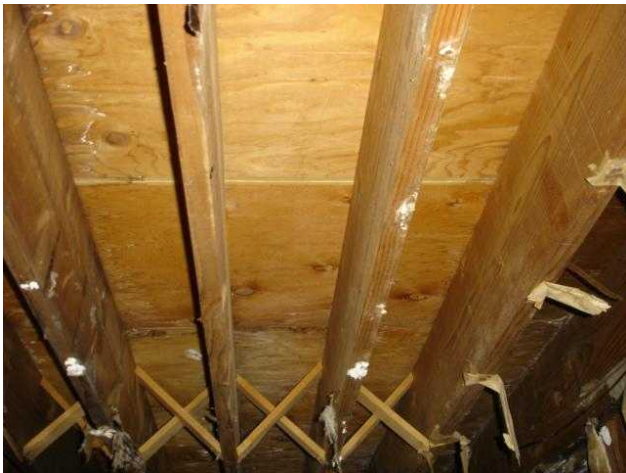
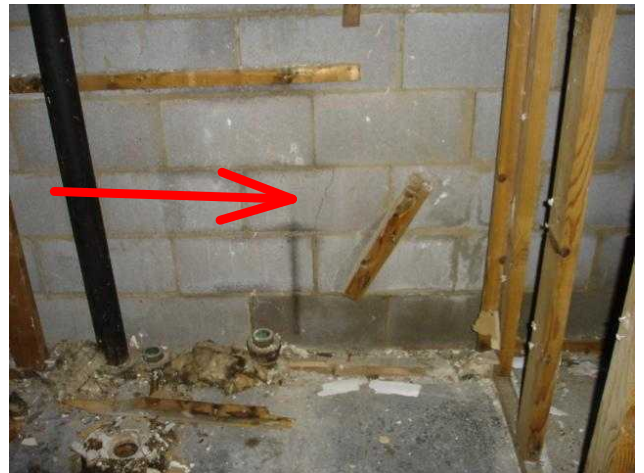
Stress Cracks

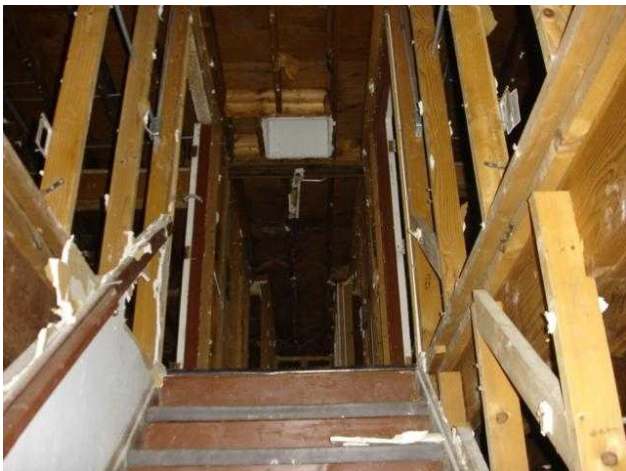
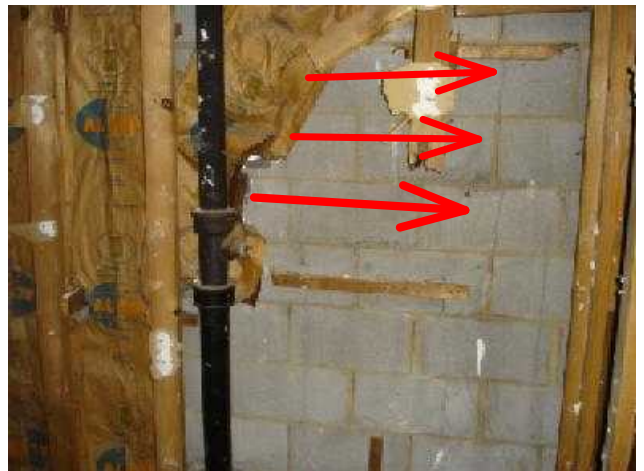
Stress Cracks
